INDOOR AIR QUALITY ASSESSMENT

**Putnam Vocational Center
1300 State Street
Springfield, Massachusetts**

Prepared by:
Massachusetts Department of Public Health
Bureau of Environmental Health Assessment
September, 2000

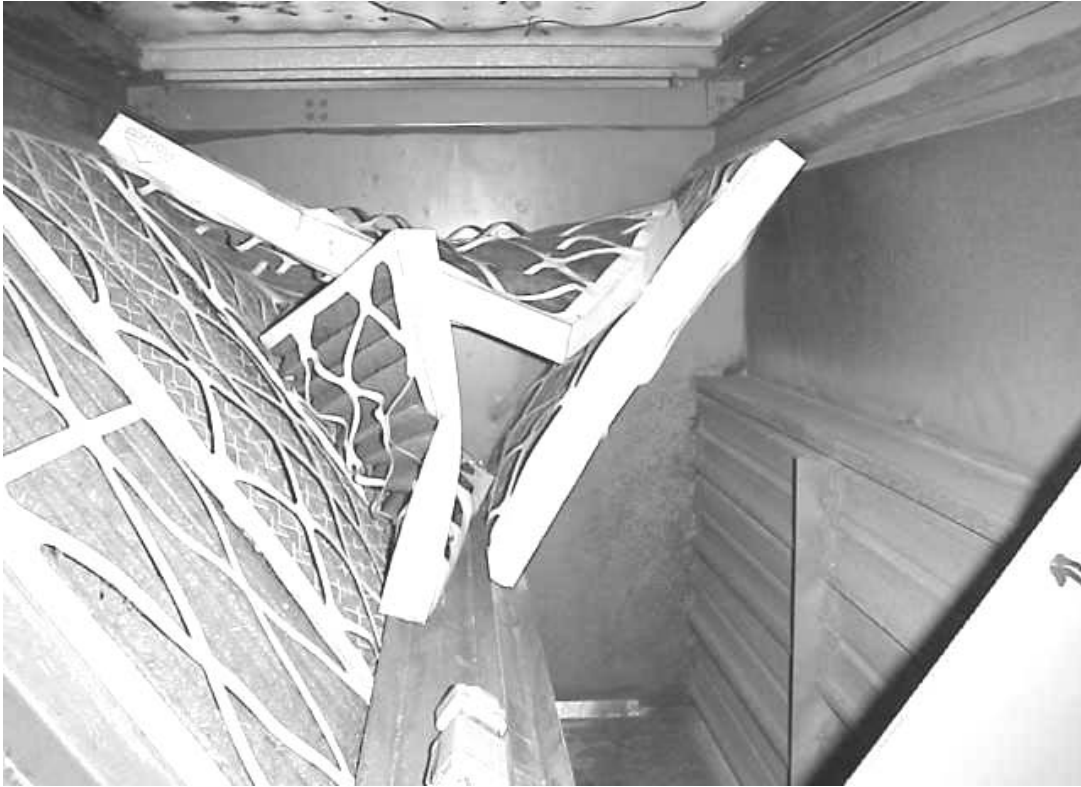
Picture 33

It is also important that air filters for air handling equipment fit flush in their racks. The interior of the AHU for the gymnasium was examined, several filters were noted missing or crushed within the unit (see Picture 33). In order to provide air filtration as designed, a complete set of tight fitting air filters should be installed and routinely replaced. Unfiltered air passing through this system can introduce mold, spores and nutrients into this air handler. With the addition of moisture, mold growth can occur, leading to mold being distributed by the ventilation system. Fitting of filters into their racks to prevent spaces that allow for unfiltered air to be introduced into air handlers is necessary to reduce particulates, including mold, into the HVAC system.

Missing/Damaged Air Filters inside AHU in Gymnasium

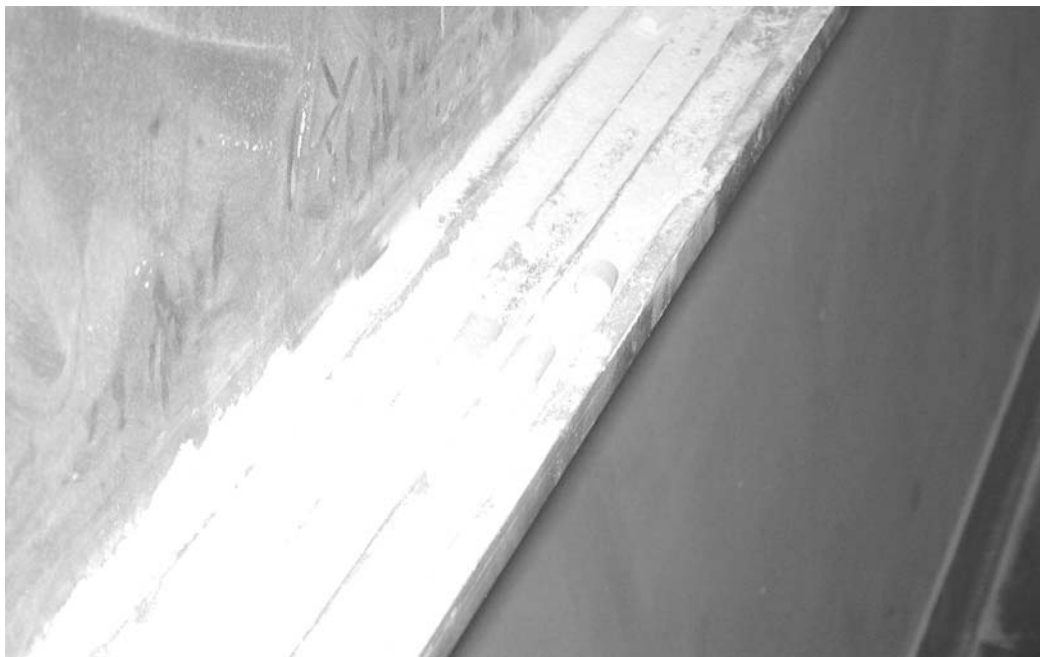
Picture 34

Accumulated chalk dust was noted in many classrooms (see Picture 34). Chalk dust is a fine particulate, which can be easily aerosolized and serve as an eye and respiratory irritant. Several classrooms contained dry erase boards and markers. Materials such as dry erase markers and cleaners may contain VOCs, (e.g., methyl isobutyl ketone, n-butyl acetate and butyl-cellusolve) (Sanford, 1999). Exposed fiberglass pipe insulation was noted in several classrooms, restrooms and hallways throughout the school. Airborne fiberglass particles can serve as a skin and respiratory irritants to sensitive individuals.

Accumulated Chalk Dust in Classroom Chalk Tray

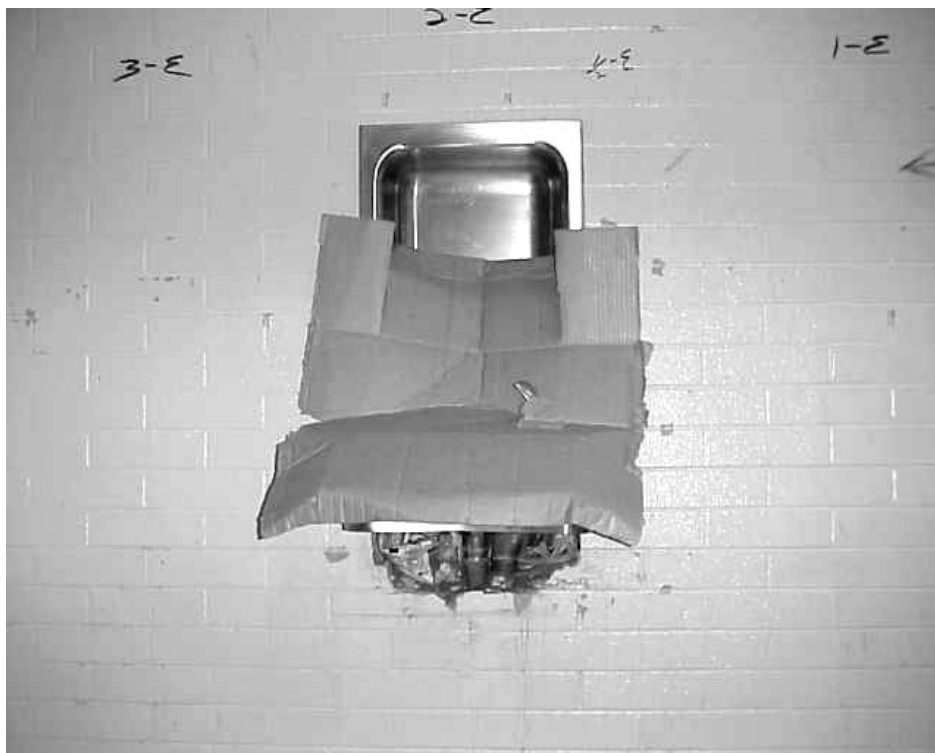
Picture 35

Abandoned Water Fountain in Gymnasium

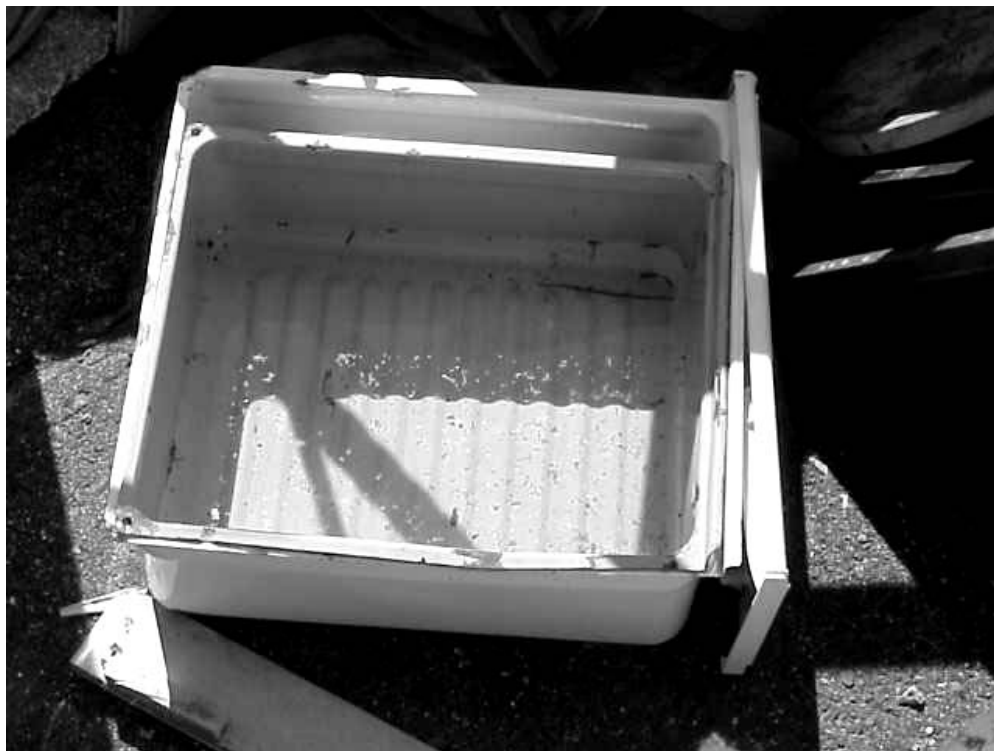
Picture 36

Stored materials around the exterior of the building were found to have mosquito eggs floating in accumulated standing water (see Picture 36). Standing water can serve as a breeding ground for mosquitoes and should be removed were found.

Container with Floating Mosquito Eggs
